**INSPECTION REPORT (BULLDOZER)**

Model	CD5PB
S/No.	611-6597
Hour/Km	stopped at 807
Eng. Model	S4E
Eng.No.	052345

**Eikoh Trading Inc.**

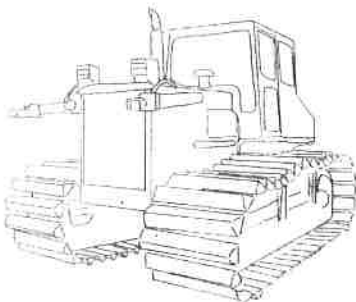
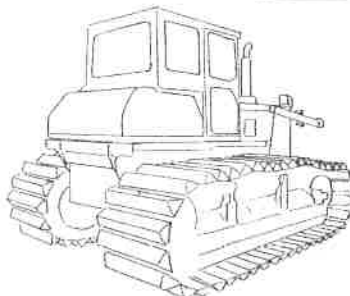
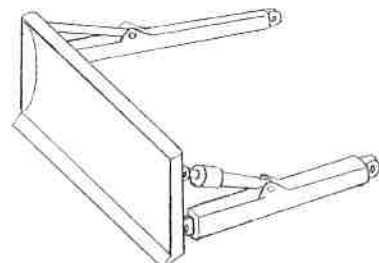
Normal working condition  
 No mechanical problem  
 1pc. bottom roller broken, front idler adjust cylinder welded

Under Carriage	<u>Left 65%</u>	<u>Right 65%</u>
Shoe		
Link		
Bushing		
Sprocket		
Top roller		
Bottom roller		<u>1pc. broken</u>
Idler	<u>Adjust cylinder welded</u>
